CULTURAL RESOURCES IN THE PROJECT CORRIDOR

New Jersey Turnpike Interchange 6 to 9 Widening
Burlington, Mercer and Middlesex Counties
Executive Order No. 215
Environmental Impact Statement

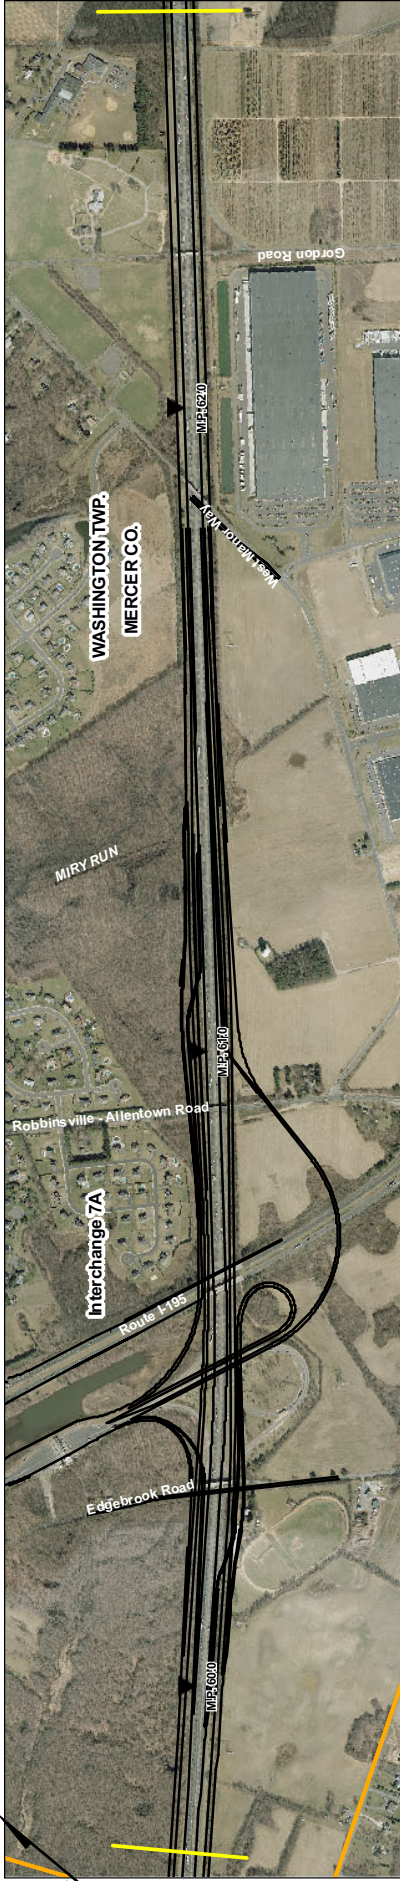
FIGURE
3-12c

CULTURAL RESOURCES IN THE PROJECT CORRIDOR

All of the previously-recorded and field-identified cultural resources within the Project Corridor that are discussed below are graphically depicted in Figures 3-12a through 3-12f.

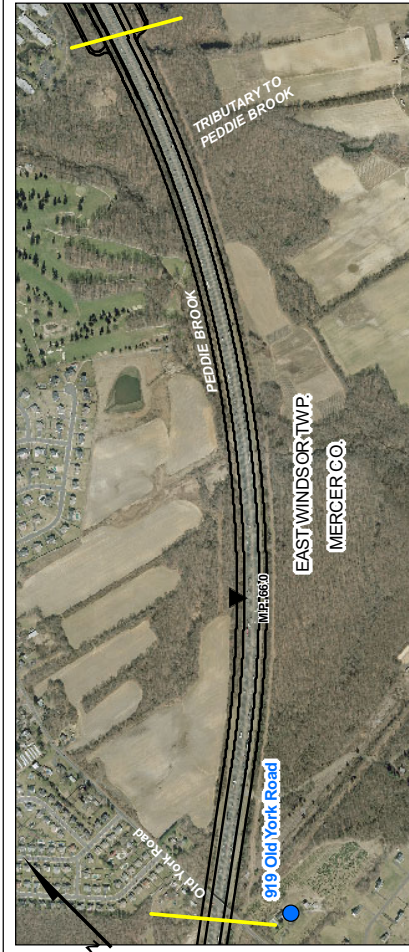
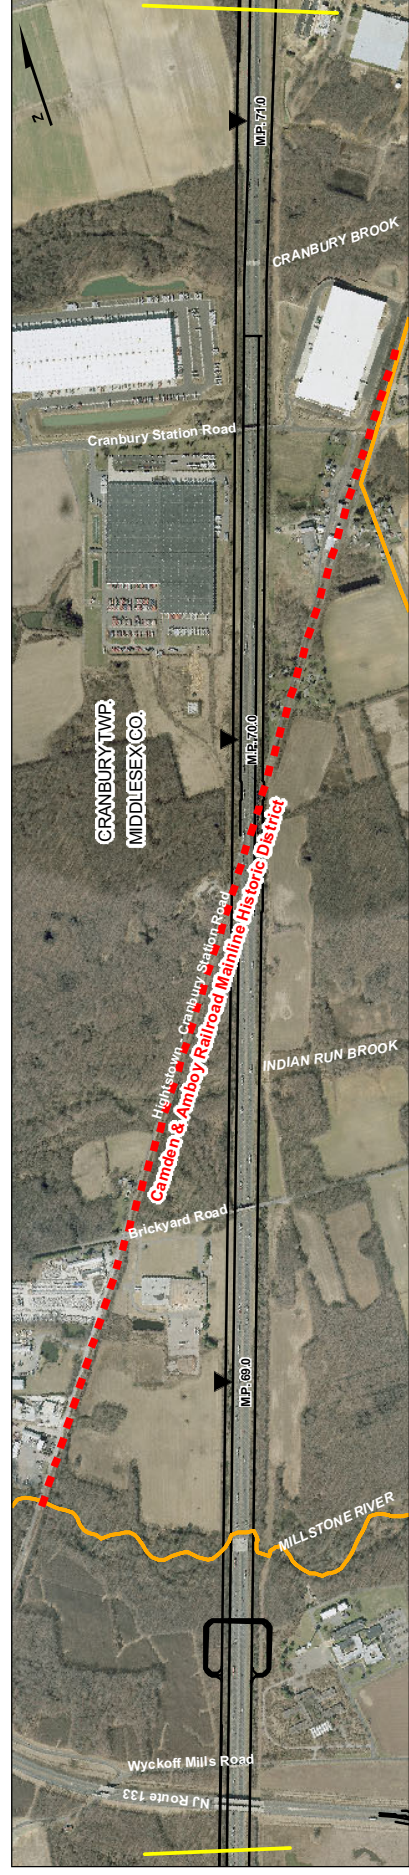
| NEW JERSEY TURNPIKE AUTHORITY NEW JERSEY TURNPIKE | FIGURE 3-12d |

| CULTURAL RESOURCES IN THE PROJECT CORRIDOR | |

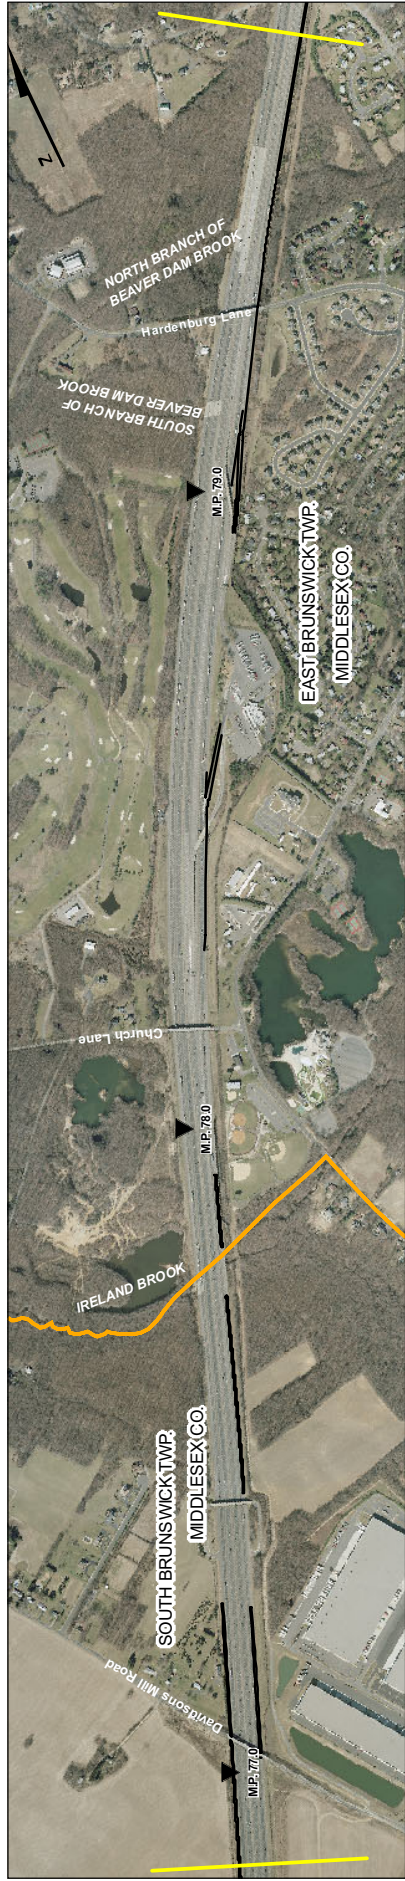
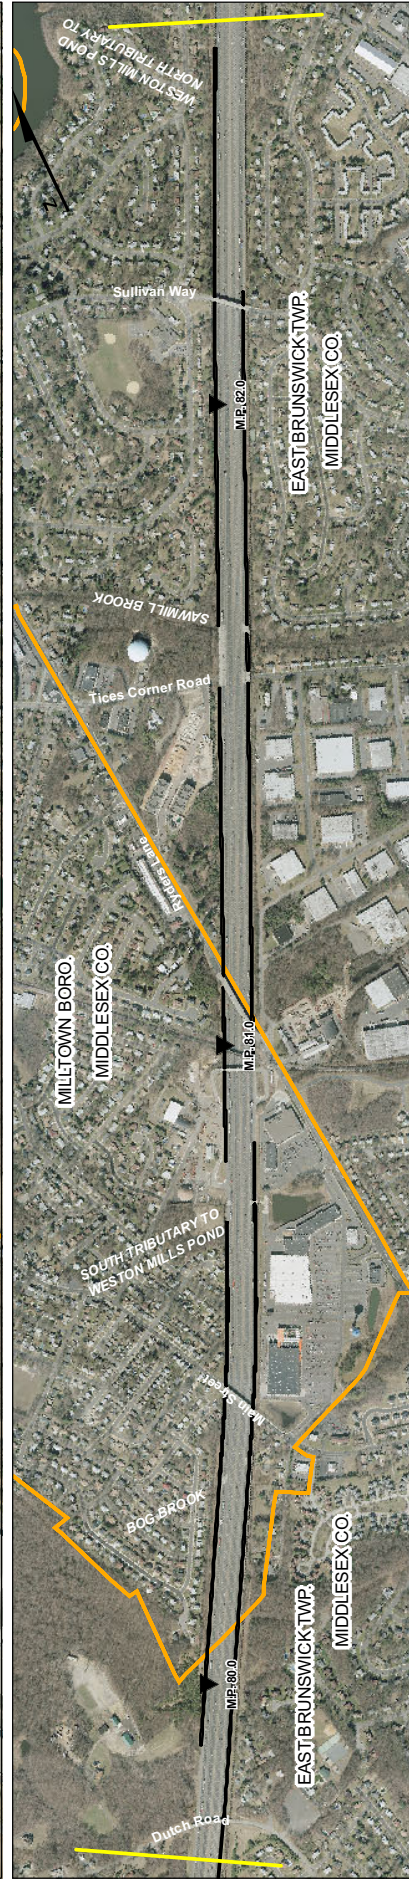
FIGURE
3-12f

| CULTURAL RESOURCES IN THE PROJECT CORRIDOR |

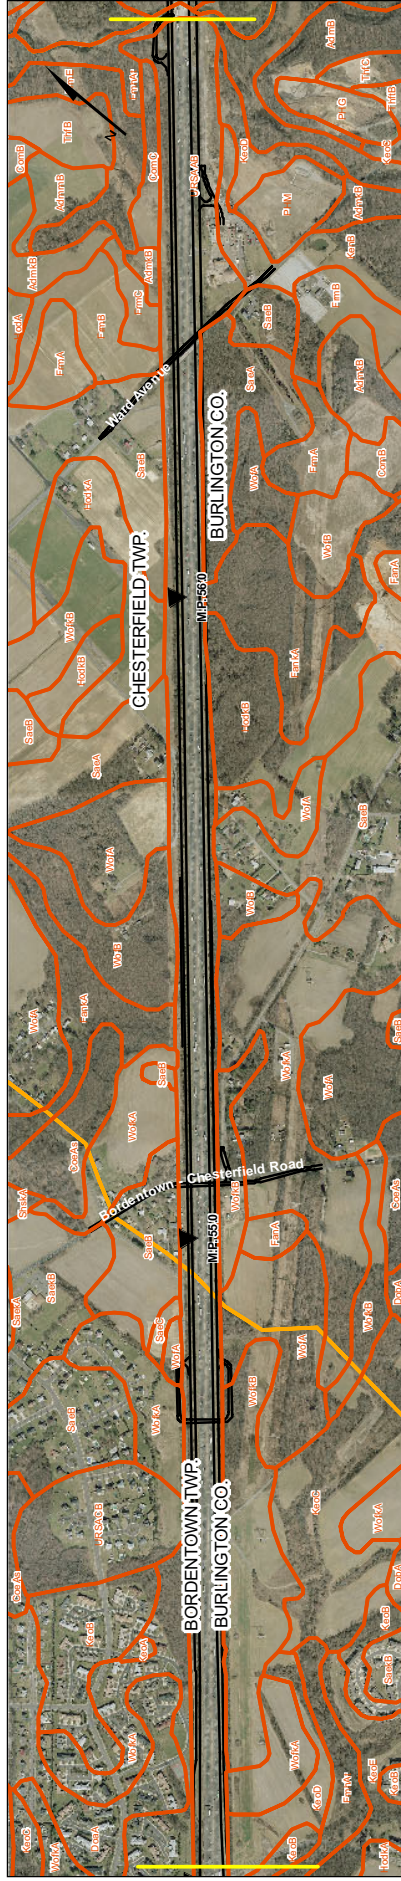
| NEW JERSEY TURNPIKE AUTHORITY NEW JERSEY TURNPIKE | FIGURE 3-14b |

- Matchline
- Municipal / County Boundary
- Soil Unit Boundary

A description of the soil characteristics associated with each soil type found within each of the three counties comprising the Project Corridor (i.e., Burlington, Mercer and Middlesex) is provided in Appendix A. The locations of all soil types within and adjacent to the Project Corridor are depicted in Figures 3-14a through 3-14f.

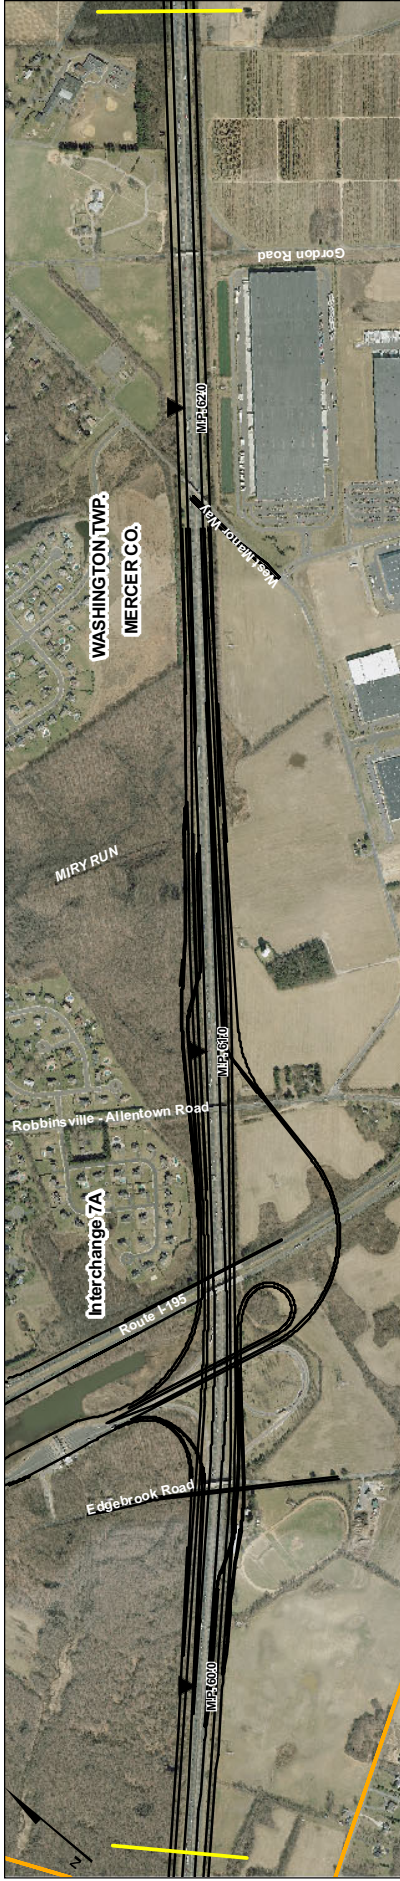
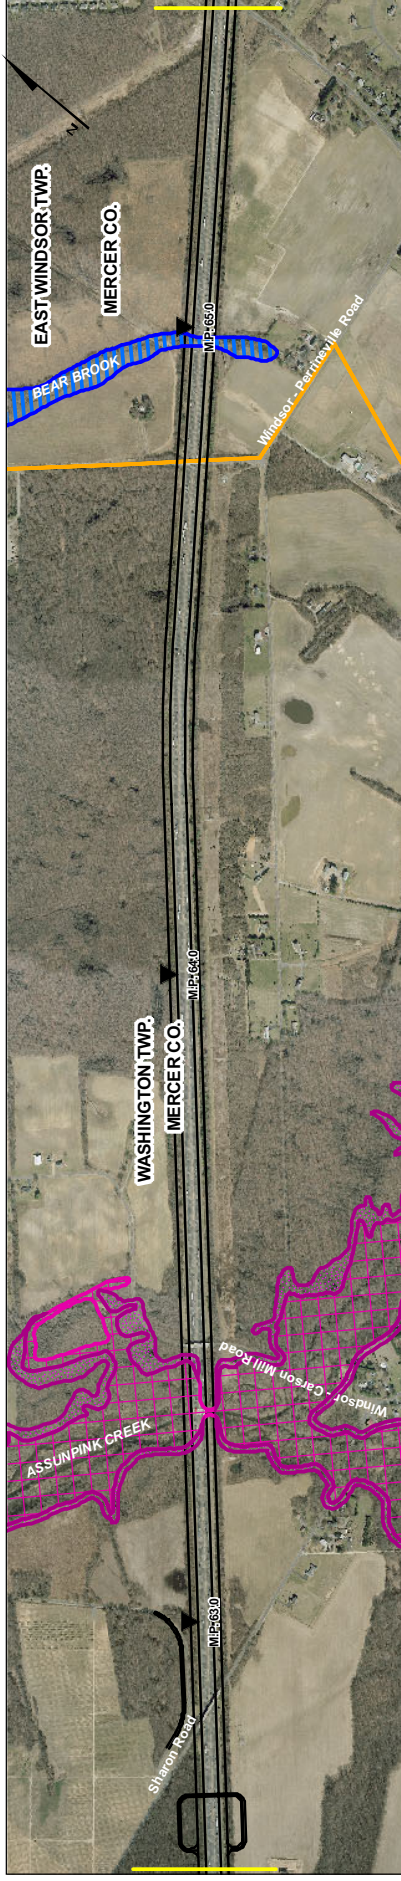
FIGURE
3-16c

Note: In some instance floodplain data may predate digital orthophotos. Stream crossings shown without FEMA flood zones have not been mapped by FEMA.
Source: Q3 Digital Flood Data for Burlington, Mercer and Middlesex County, N.J., 1996. Digital Orthophotos - 2006 Aerial Photography.

Between the southern terminus of the Proposed Project located south of Interchange 6 and the northern terminus near Interchange 9, a total of 28 streams cross the Turnpike, all of which are non-tidal freshwater streams. The streams range from intermittent runs flowing through concrete culverts, to creeks and rivers up to 40 feet wide. A summary of each of these streams and waterways, including location, active channel width, type of Turnpike crossing structure, NJDEP surface water classification and total drainage area, is provided in Table 3.44. In that table, streams and waterways are listed in south to north order. The locations of all streams within the Project Corridor, as well as the associated flood zones for FEMA-mapped streams, are graphically depicted in Figures 3-16a through 3-16f.
